AFWAL-TR-81-4019
Volume II

PROCEEDINGS OF THE 1980 TRI-SERVICE
CONFERENCE ON CORROSION

November 1980

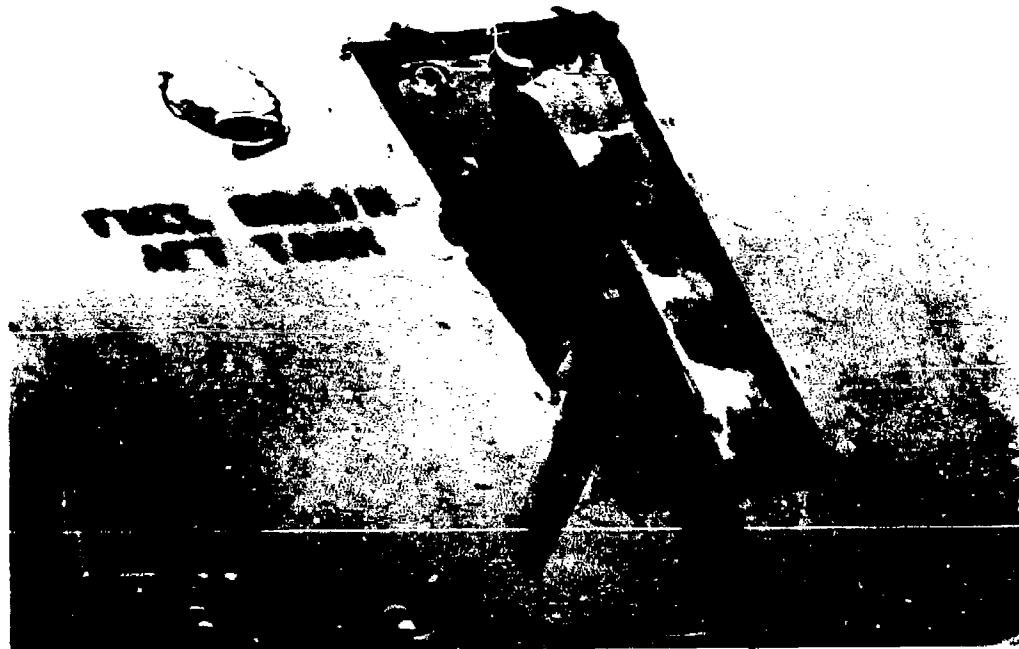
Figure 8. Sealed A-7 Lower TACAN/IFF Antenna
